Report Index

INSPECTION CONDITIONS

FILE #: My Report Rocks!
TIME OF INSPECTION: 9:00 Am.
CLIENT NAME: My Report Rocks!
INSPECTION SITE: Some where in LA.

MAIN ENTRY FACES: East.
ESTIMATED AGE OF HOUSE: 1939.
BUILDING TYPE: 1 family.
STORIES: 2
SPACE BELOW GRADE: Crawl space, Basement / **Finished basement CHECK WITH CITY BUILDING DEPARTMENT FOR PERMIT.**

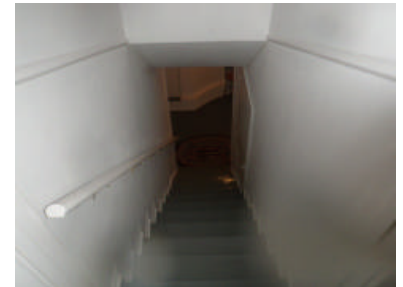
Stairs/Handrails: functional to basement / **low ceiling use caution / Recommend installation light over stairwell.**

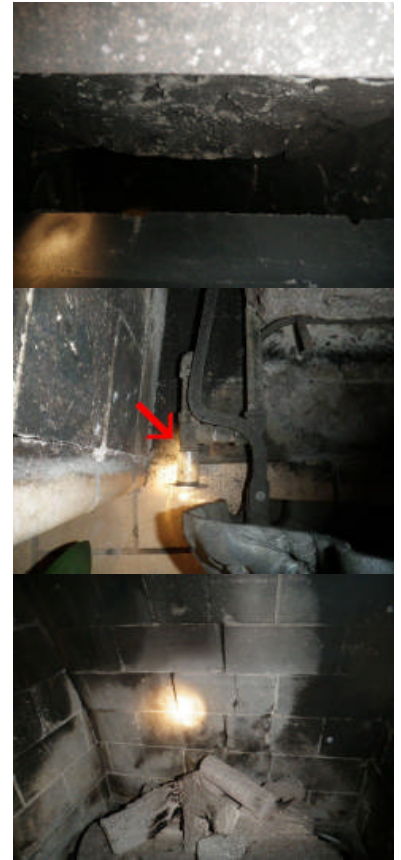
Location 1: Living room.

mason built, no damper door Normal For Age Of Home, gas valve in fire box, Not To building Standards use caution and or upgrade / loose bricks/mortar present repairs needed - Further Evaluation Recommended By Related Qualified Licensed Contractor / FIREPLACE- NOTE: This inspection of the fireplace is a visual inspection only, and is not a warranty and/or guarantee that the fireplace's, chimney's, and termination caps has/have been properly or safely installed/built. No seismic damage assessments are made on fireplace's.

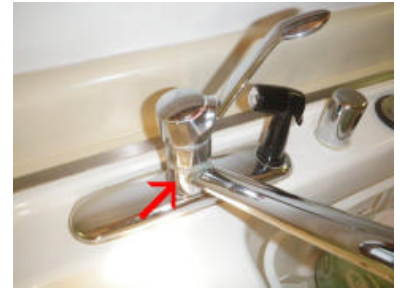
TYPE AND CONDITION: Appears Serviceable / valve/faucet leaks while operating. CORRECTION RECOMMENDED.

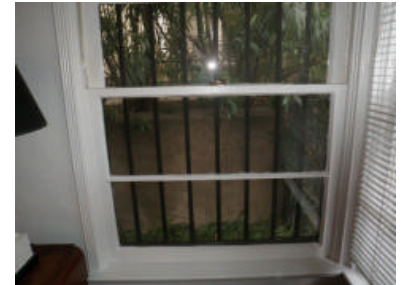
wood, stuck in position, windows painted shut, difficult to slide / functional - recommend corrections.

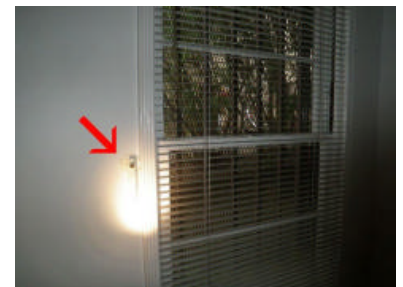
Type: wood, **stuck in position, windows painted shut, difficult to slide / functional - recommend corrections.**

Security Bars: **present N/A not tested consult seller on operations and testing.**

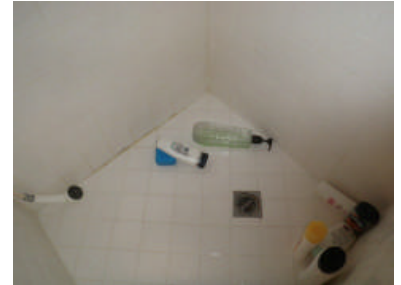
cracked tiles present. / rec. caulking/grout.

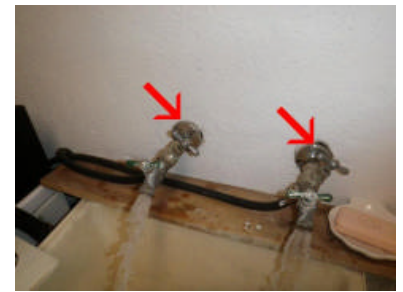
using laundry tub / supply loose recommend anchoring / Appears Serviceable.

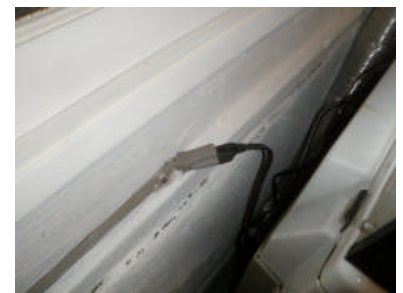
Appears Serviceable / using extension cord recommend permanent power upgrading for dryer.

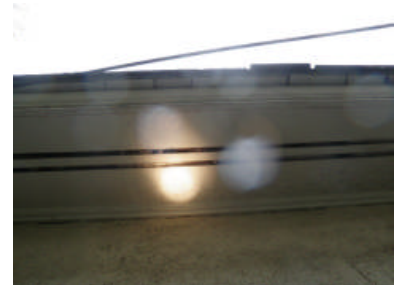
Deteriorated voids present CORRECTION RECOMMENDED.

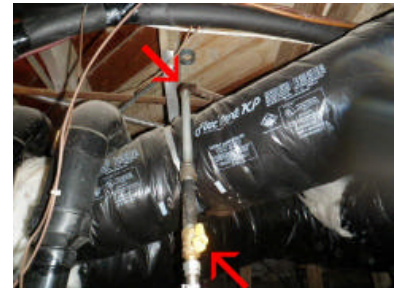
Appears Serviceable / Recommend additional anchoring.

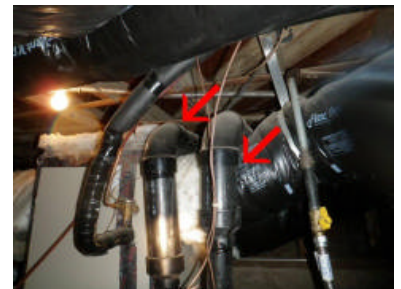
7. VENTING

Using plastic ABS - IRREGULAR / Normal PVC Schedule 40 - Further Evaluation Recommended By Related Qualified Licensed Contractor Within Contingency Period.

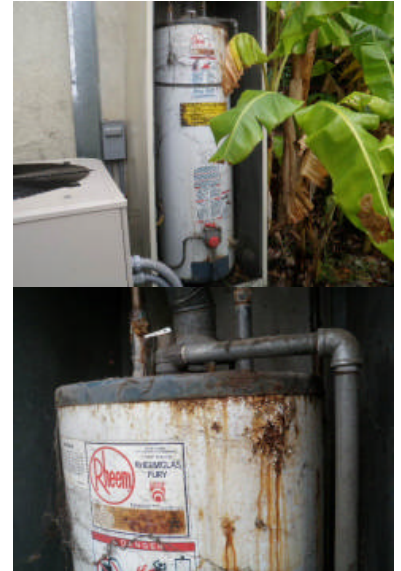
Type/Condition gas, operated, Number Of Gallons:40 / rust in chamber, rust on casing unit worn.

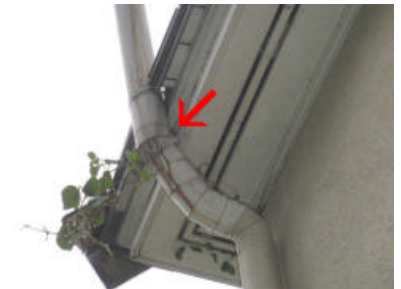
2. VENTING

Type/Condition Rusted section / Contact to eave structure Not To building Standards, CORRECTION RECOMMENDED.

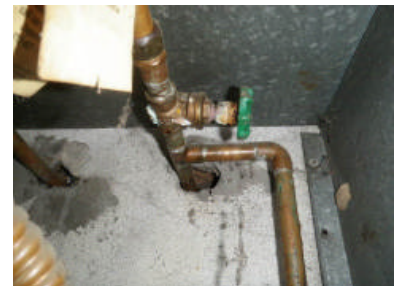
3. PLUMBING

Type/Condition copper, slight/heavy corrosion, worn fixtures gate valve Gate valve present / Gate valve's depending upon the age are not tested. Due to the temperamental functional of a gate valve closing and not opening and leaking after adjustment the valves are not moved from current position, it is recommended that you upgrade to more reliable ball valve.

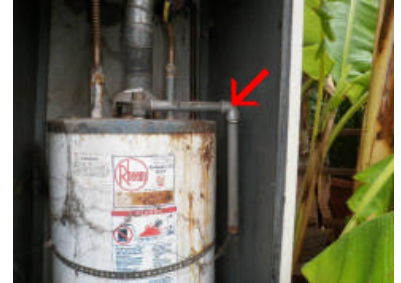
Type/Condition galvanized, discharges greater than six inches above slab, Not To building Standards / Copper recommended.

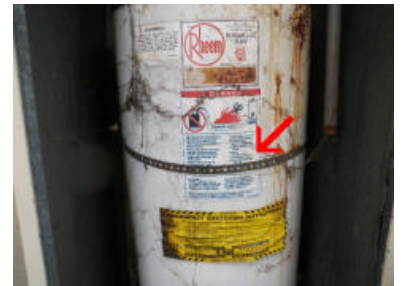
6. STRAPPING

Type/Condition irregular, not secured properly, requires two 1 1/2' straps of 16 gauge steel, 1/3 from top & bottom, CORRECTION RECOMMENDED.

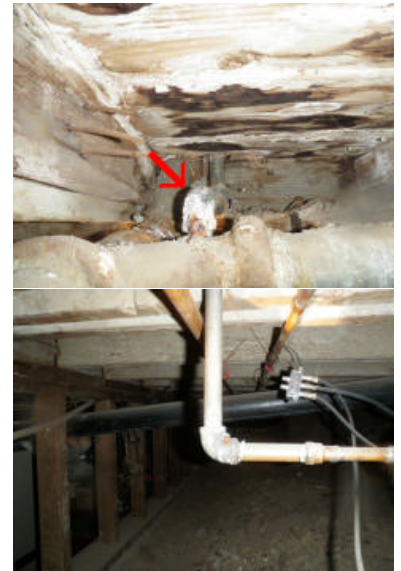
CONDITION: No leakage is noted, but monitor in the future / Minor corrosion is noted / Normal for Age of Material Appears Serviceable / **Major corrosion is noted at bathroom Galvanized vertical feeds original plumbing recommend completing upgrading System appears to be nearing/at end of its useful life.**

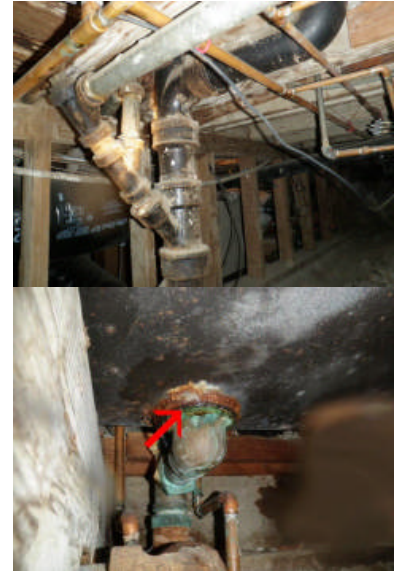
Rust/Corrosion noted, Unable to fully view pipes / Leaks noted at tub drainage system heavy corrosion present Further Evaluation Recommended By Related Qualified Licensed Contractor Within Contingency Period / DRAINAGE TESTING Note that water is ran continuously in Kitchen and bathroom's during inspection of that area slow drainage is noted if occurring however it is beyond the scope of this inspection to report or have access to main drain condition. It is recommended for properties 1950 and older to do a video line interior inspection to determine condition of main drain line /

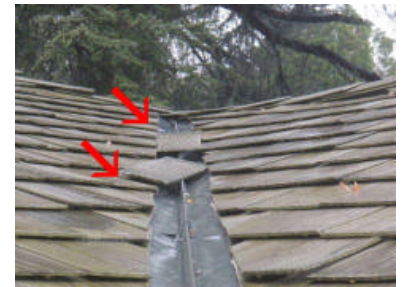
Multiple layers present Composite light weight concrete base over original wood shake no underlayment paper visible / missing/loose shingles/tiles viewed service needed typical roof tune up condition it is recommended to have a roofing contractor familiar with this type of roofing material to make corrections needed and install mastic at all flashings needed.

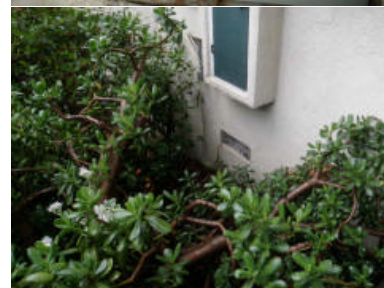
Circuit and wire sizing correct so far as visible, Grounding system is present / Appears Serviceable / **Conditions present Panels are without the benefit of complete labeling - Access poor due to plant growth a 30"x30" access and approach is recommended / CORRECTION RECOMMENDED.**

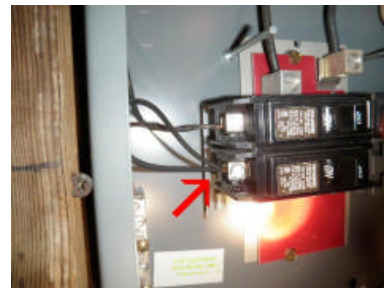
0 / Main Appears Serviceable / **Sub Appears Serviceable two wires to one breaker, Not To building Standards, CORRECTION RECOMMENDED.**

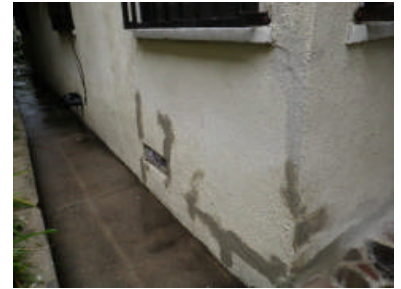
7. STUCCO

Type/Condition: Overall Appears Serviceable, Normal For Age Of Home, Normal for Age of Material / **Some areas N/A-Recommend plates/shrubs be cut away from structure. cracking present patching present consult seller on history.**

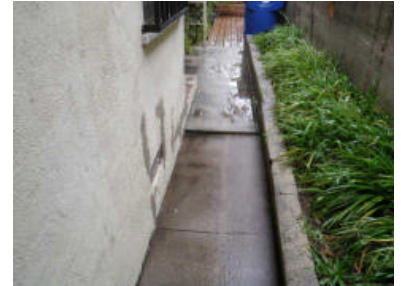
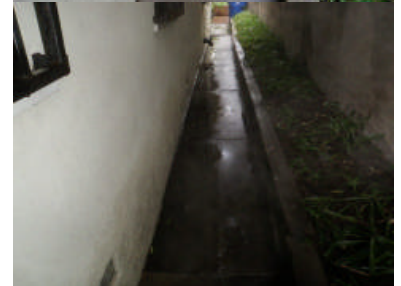
Irregular step height and approaches present Normal For Age Of Home / Loose stone present front steps repair needed / **Concrete cracked and settlement present South side water ponding from rain water against structure leaching into structure foundation - lifting, trip hazard present preventing proper water egress- Roof gutters recommended / Further Evaluation Recommended By Related Qualified Licensed drainage Contractor Within Contingency Period.**

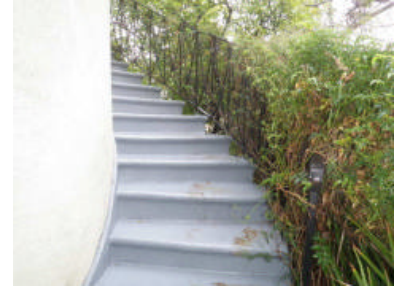
Ext. Stairs/Handrails: Front entrance decorative in style non conforming to standards / Function - little loose. Leaking stair approach cracking present and multiple water intrusion areas visible, water dripping from front entrance platform ponding on wood platform- **NOT TO BUILDING STANDARDS FURTHER EVALUATION RECOMMENDED BY RESPECTIVE QUALIFIED PERTAINING CONTRACTOR WITHIN THE CONTINGENCY PERIOD.**

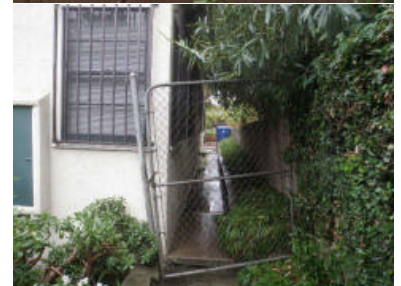
Gates: South leaning irregular / North covered with honeysuckle / Functional.

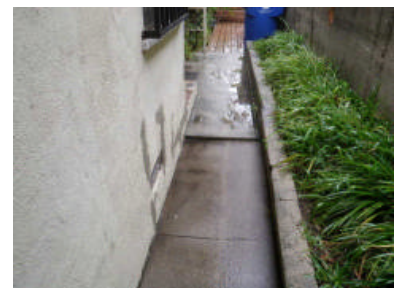
10. GRADING

Type/Condition: no drains visible, Inspector does not conduct any type of drainage testing. heavy plant growth present / trees/plants too close to structure / signs of poor drainage - settlement present South side water ponding from rain against structure leaching into structure foundation - lifting, trip hazard present preventing proper water egress- Roof gutters recommended / Further Evaluation Recommended By Related Qualified Licensed drainage Contractor Within Contingency Period.

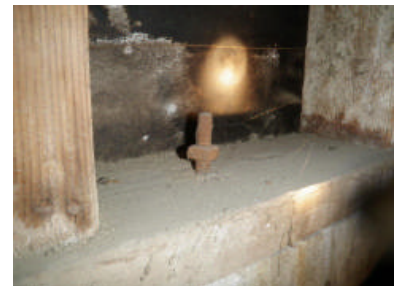
present limited normal for time of california construction / **Some nuts not tightened down correctly / Consider Retro-fitting anchoring system. See foundation report conducted.**

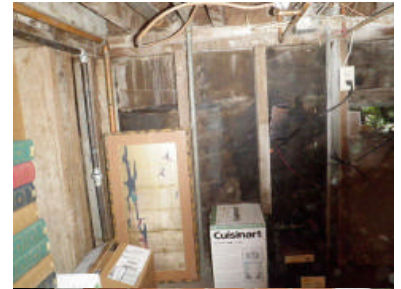
Cripple Walls: present, not reinforced / Normal for time of California construction / **Consider Retro-fitting anchoring system.** See foundation report conducted.

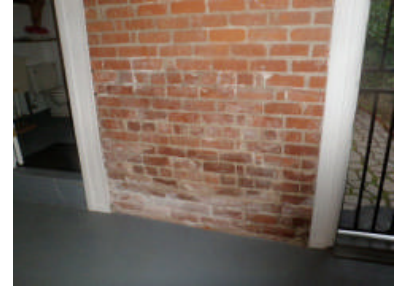
Chimney Hearth: Efflorescence present / Efflorescence is the term for lime-salts leaching from concrete and crystallizing on the surface of the concrete. This can occur on floors, masonry walls, foundations and even soil. Efflorescence is not the problem. The root cause is moisture, and this will continue to be a problem until you address the source of that moisture. Most likely, in your case, the source is irrigation in summer and poor drainage in winter. / Some cracking present. See foundation report conducted.

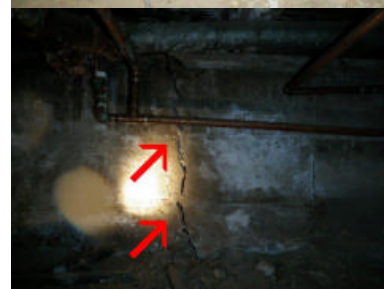
CONDITION: Cracks foundation wall South side A Structural Engineer should be called to make further evaluation and recommendations as needed - See foundation report conducted.

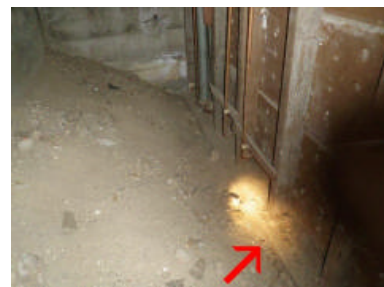
COLUMNS/SUPPORTS: Earth to wood contact present multiple areas **CORRECTION RECOMMENDED, CONSULT TERMITE REPORT FOR ALL WOODEN AREAS /** See foundation report conducted.

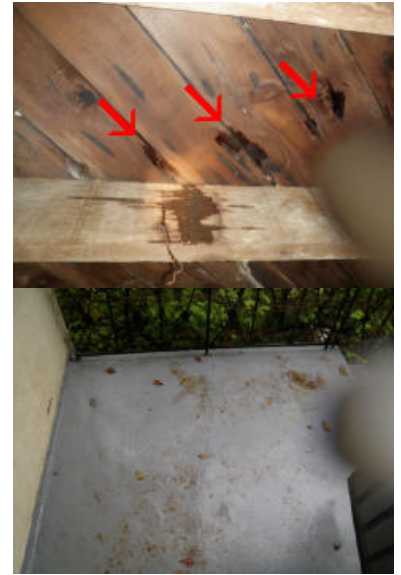
**BASEMENT FLOOR
AND DRAINAGE:**

Leaking stair approach cracking present and multiple water intrusion areas visible, water dripping from front entrance platform ponding on wood platform- NOT TO BUILDING STANDARDS FURTHER EVALUATION RECOMMENDED BY RESPECTIVE QUALIFIED PERTAINING CONTRACTOR WITHIN THE CONTINGENCY PERIOD.
