Report Index

INSPECTION CONDITIONS

FILE #: 598 - 032217JS Inspection Order Number (OID): 598.
DATE OF INSPECTION: 3/22/2017.
TIME OF INSPECTION: Start time 8:30 Am.
CLIENT NAME: SAMPLE REPORT.
INSPECTION SITE: 1820 Fairmount Ave.
INSPECTION SITE La Canada Flintridge, CA 91011.
CITY/STATE/ZIP:

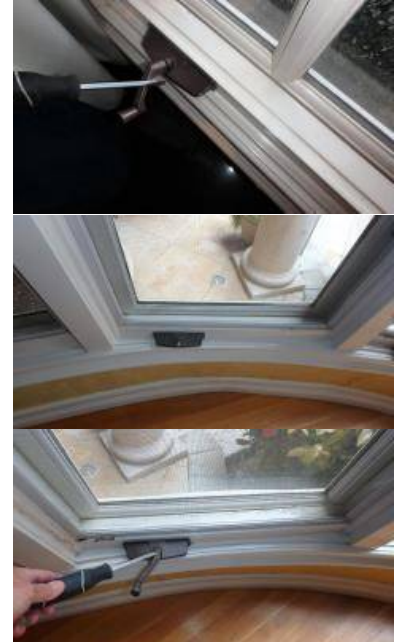
Multiple systems present wood, crank style - Note: Multiple crank arms loose, missing, tune up corrections needed, all accessible tested Appear serviceable.

tune up corrections needed,

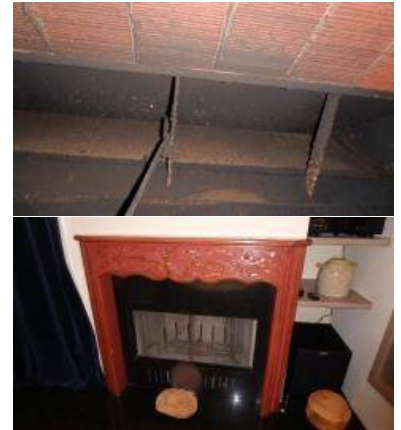
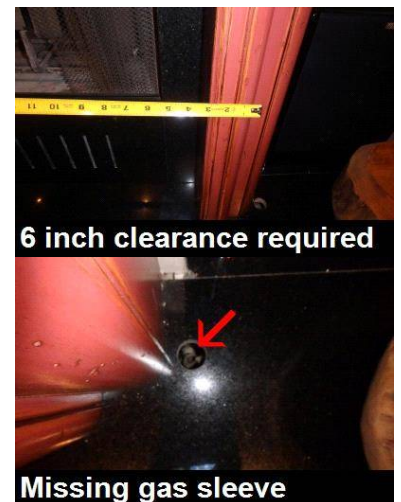
Theater room / prefabricated - gas log lighter, **no damper door/clamp - NTBS Missing gas sleeve - NTBS - Wood surround too close at sides - NTBS** "Based on the industry standards and the limited inspection required by these standards, the fireplace appears to be in operable condition.", FIREPLACE- NOTE:

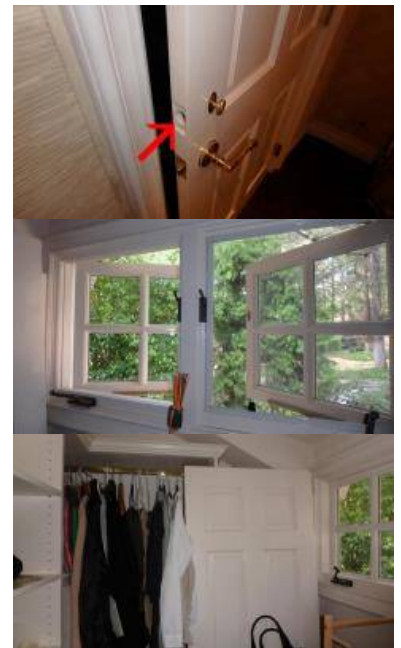
Type: Appear Serviceable, Functional, Door stopper missing rubber tip. **Missing dead bolt.**

Closets/Cabinets: Appears Serviceable, most N/A due to personal items, Appears Serviceable, , wood crank style Windows present functional **missing 1 screen.** Bathroom door noted in closet.

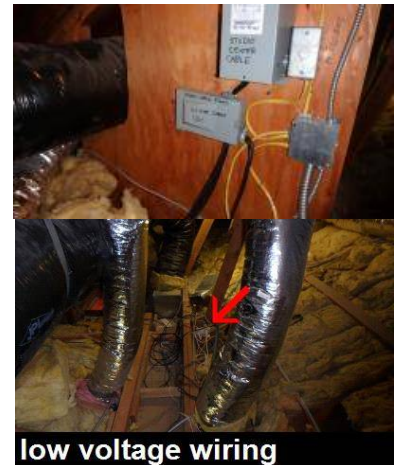
most is not visible due to insulation, Visible appears serviceable, Note extensive excessive low voltage wiring present not in uniform installation condition. Low voltage systems not part of inspection.

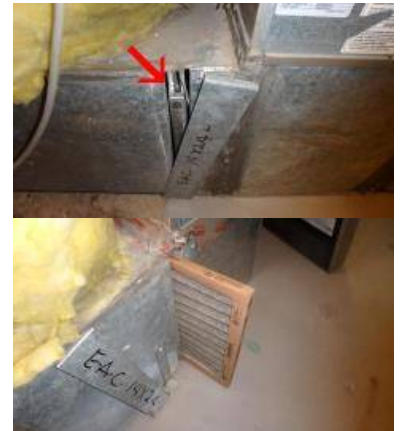
Unit - 4 regular filter dirty.

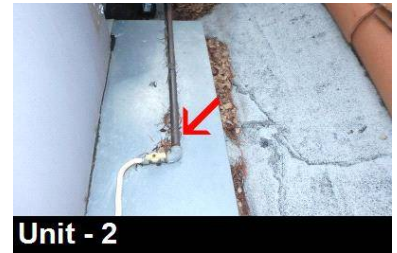
Unit - 1 Appears Serviceable, **Recommend anchoring** / Unit - 2 Appears Serviceable, **Recommend anchoring** / Unit - 3 & 4 Appears Serviceable. Unit - 5 Appears Serviceable / Unit - 6 N/A.

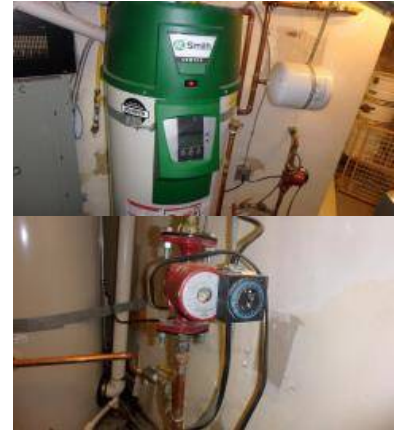
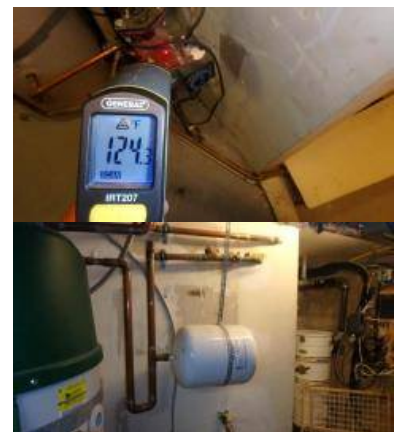
Potable Water Expansion Tank Present / Potable water expansion tank present Appears Serviceable. An expansion tank is a small tank used in closed water heating systems and domestic hot water systems to absorb excess water pressure. Excess pressure can be caused by thermal expansion as water is heated, or by water hammer. The expansion tank usually contains a rubber diaphragm and the bottom of the tank contains water, which is openly connected to the plumbing system. Anytime the water pressure rises, it will push against the diaphragm, and gently compress the air. The compressibility of the air cushions the pressure shock, and relieves pressure in the system that could otherwise damage the plumbing system. MFG DATE: 3/21/2012 Newer unit check for permit / Note: **Expansion tank plumbing needs additional anchoring.**

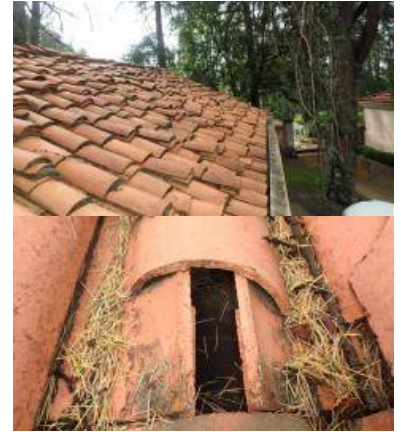
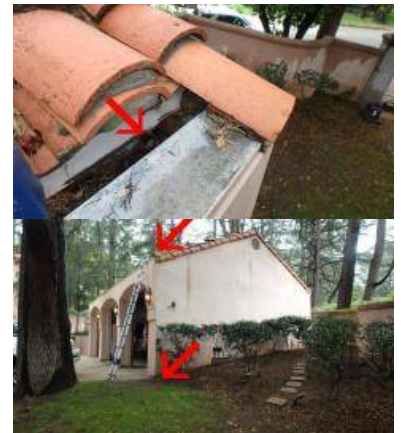
Spanish clay double/triple system present appears serviceable, **Conditions present, excessive tree debris present, multiple cracked, slipped tiles present, exposed underlayment** A professional roof tune up is required at this time. Recommend licensed roofing contractor for further evaluation Further Evaluation Recommended By Related Qualified Licensed Contractor Within Contingency Period. Note; Back roof gutter system restricted by debris, Cleaning required to perform properly does not divert water away from structure corrections needed - Note Front system present incorporated into structure restricted by debris, Cleaning required to perform properly, the down spout is inner structure Not Accessible/Did Not Inspect and filled with the debris, the outlet is unknown - Further Evaluation Recommended By Related Qualified Licensed Contractor Within Contingency Period. Gutter system.

Unknown gutter outlet Further Evaluation Recommended.

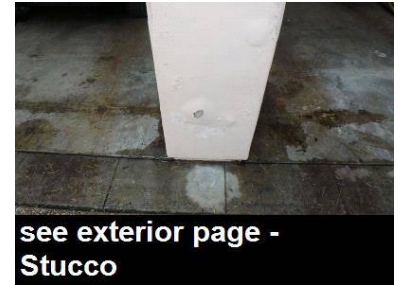
Appears Serviceable, cracked, Normal for Age of Material, Multiple chips and cracking present oil stains present typical conditions, note water intrusion at South side possibly related to recent rain and door conditions.

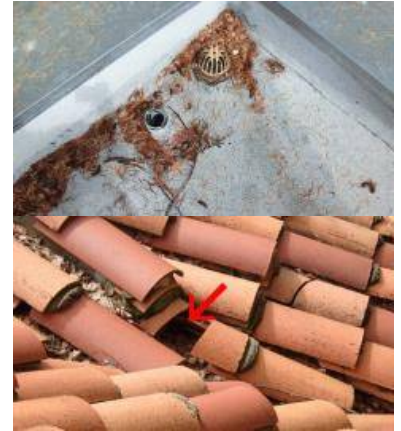
Debris.

exposed felt.

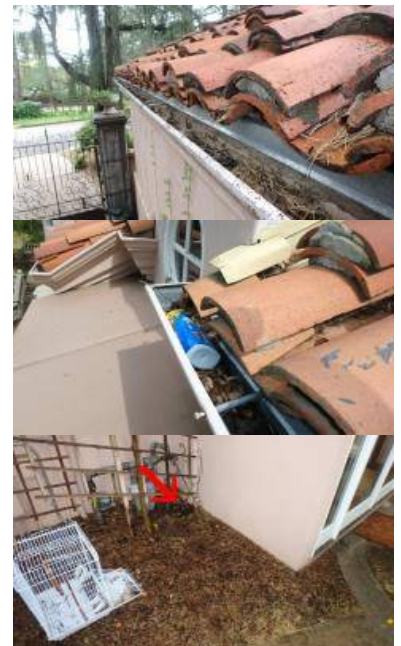
restricted by debris, cleaning needed.

does not divert water away from house in areas, corrections needed.

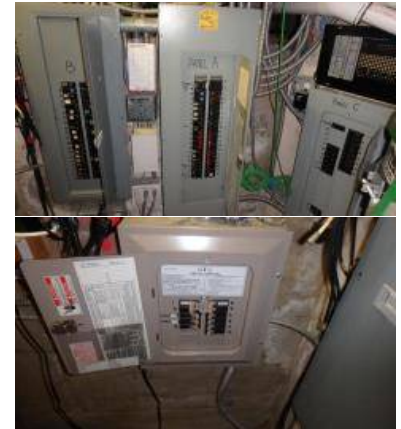
Additional sub panel locations and conditions as follows - Basement Sub - A / Sub - B / Sub - C - All Appears Serviceable, Normal for California construction - Note: **Additional Sub Panel present noted for generator however a generator was not discovered - Not Inspected/Excluded From Report/Consult Seller / Further Evaluation Recommended By Related Qualified Licensed Contractor Within Contingency Period.**

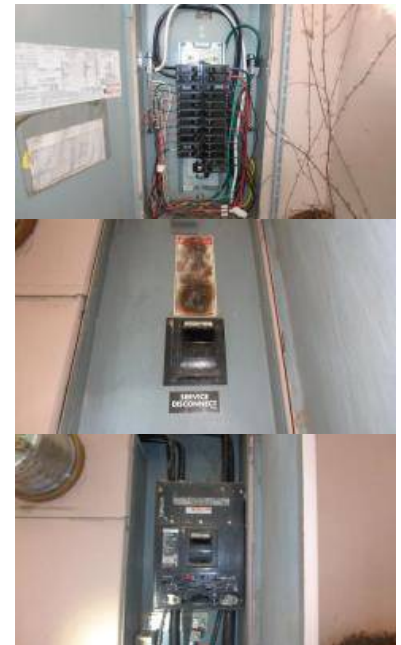
400 Amp Main / Note: **The label at the main has been scorched in the past, unknown occurrence, consult seller on history - Have a licensed electrician make further evaluation.**

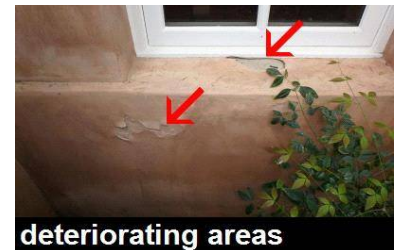
Overall stucco body Appears Serviceable, Normal For Age Of Home, Normal for Age of Material, **blistered, deteriorating areas are noted at base and some structure areas due to water intrusion, excessive moss is present at North side due to poor roof drain and lack of gutter and or roof flashings, past and present wondering ivy plant growth has effected stucco by rooting into stucco considered a cosmetic condition, it is recommended to power wash home and patch and match paint at deteriorated and cracking areas present - Further Evaluation Recommended By Related Qualified Licensed Contractor Within Contingency Period.** Stucco weep screed improper clearance between weep screeds and the finished grade. The metal weep screed installed around the bottom of your home is to allow any water that gets past the stucco to safely exit. There should be a minimum clearance of 4 inches between the weep screed and the finished grade. If concrete walkways or some other hard surface is installed up to the foundation of the home, there should be a minimum clearance of 2 inches between the weep screed and such concrete or hard surface. Care should be taken to ensure that weep screeds are not covered by landscaping or concrete walkways.

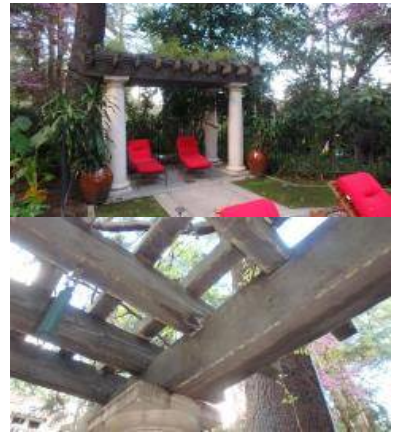
shade type/wood, unknown fungus noted - CONSULT
TERMITE REPORT FOR ALL WOODEN AREAS.

CONSULT TERMITE REPORT FOR ALL WOODEN
AREAS.

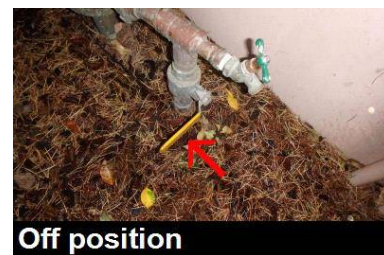
Approximate PSI

80 - 90 High pressure considerations.

Pressure Regulator: present Appears Serviceable, Not tested High pressure noted recommend adjusting pressure normal range 60 - 80 PSI.

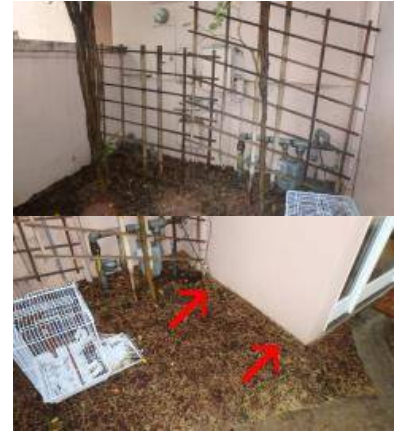
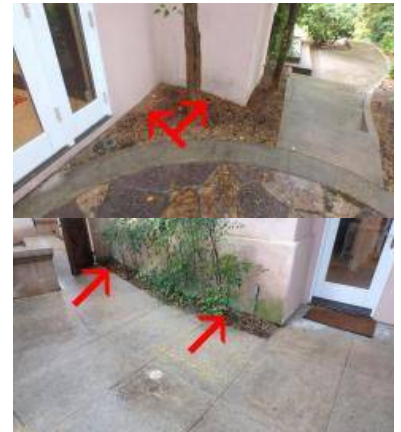
Stucco weep screed improper clearance between weep screeds and the finished grade. The metal weep screed installed around the bottom of your home is to allow any water that gets past the stucco to safely exit. There should be a minimum clearance of 4 inches between the weep screed and the finished grade. If concrete walkways or some other hard surface is installed up to the foundation of the home, there should be a minimum clearance of 2 inches between the weep screed and such concrete or hard surface. Care should be taken to ensure that weep screeds are not covered by landscaping or concrete walkways.

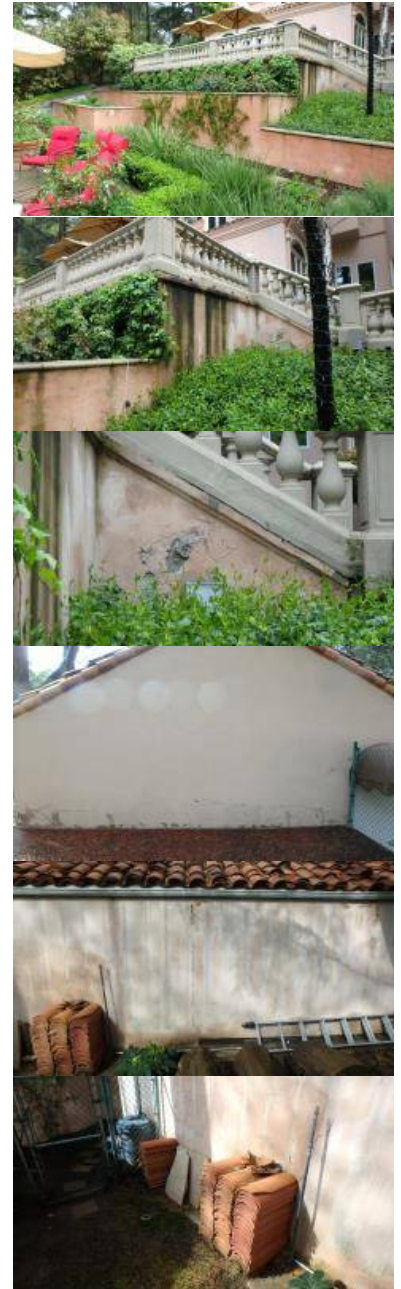
Stucco stained from poor gutter drainage at garage.

Extra tiles on grounds.
