Report Index

INSPECTION CONDITIONS

FILE #: My Report Rocks!
TIME OF INSPECTION: 9:00 Am.
CLIENT NAME: My Report Rocks!
INSPECTION SITE: Some where in LA.

MAIN ENTRY FACES: East.
ESTIMATED AGE OF HOUSE: 1939.
BUILDING TYPE: 1 family.
STORIES: 2
SPACE BELOW GRADE: Crawl space, Basement / **Finished basement CHECK WITH CITY BUILDING DEPARTMENT FOR PERMIT.**

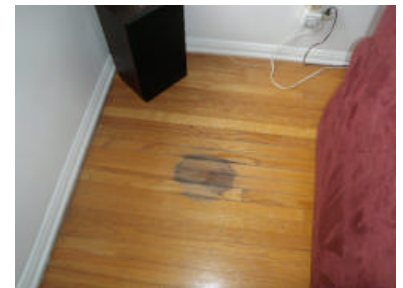
3. FLOORS

Type hardwood, area rugs present, stained, worn, squeaky, Normal Living Condition, Normal for Age of Material, Normal For Age Of Home. **stained.**

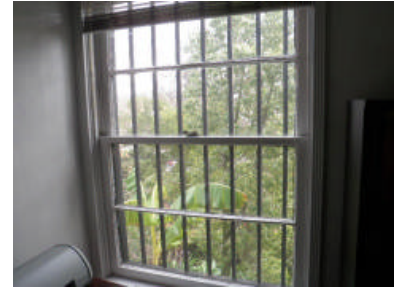
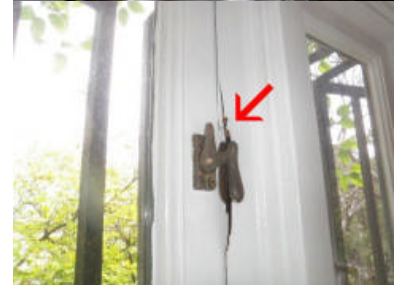
4. WINDOWS

Type: Functional, wood, crank style / broken upper lock set dining room / stuck in position in office / Loose crank handle right side living room - CORRECTION RECOMMENDED.

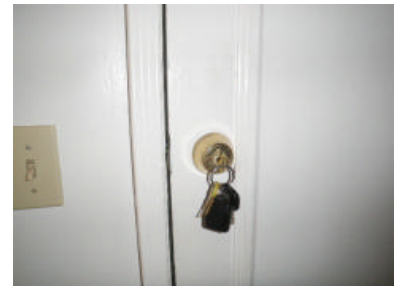
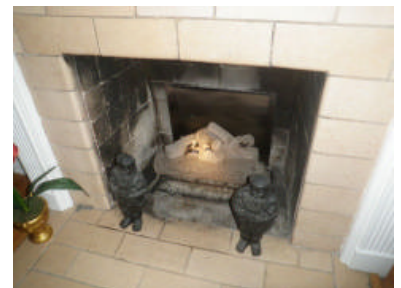
Location 1: Living room.

mason built, no damper door Normal For Age Of Home, gas valve in fire box, Not To building Standards use caution and or upgrade / loose bricks/mortar present repairs needed - Further Evaluation Recommended By Related Qualified Licensed Contractor / FIREPLACE- NOTE: This inspection of the fireplace is a visual inspection only, and is not a warranty and/or guarantee that the fireplace's, chimney's, and termination caps has/have been properly or safely installed/built. No seismic damage assessments are made on fireplace's.

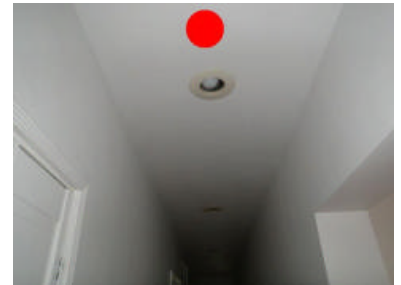
Smoke Detectors:

Tested by testing button only test unit monthly living room / No unit present in hallway required. CORRECTION RECOMMENDED.

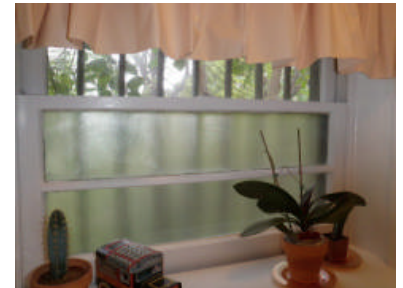
4. WINDOWS

Type: Functional, wood / **difficult to slide over sink**. Appears Serviceable.

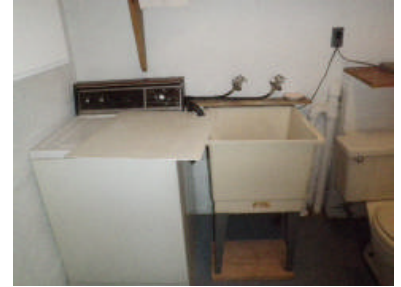
Type: drywall, plaster, concrete , stucco Normal for Age of Material, Normal For Age Of Home
Appears Serviceable.

**wash and dryer
prevents full inspection**

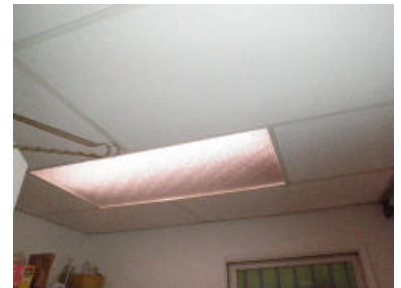
Type: tile squares not opened Not Inspected/Excluded From
Report/Consult Seller.

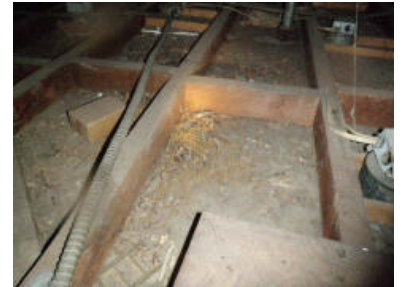
None. Debris present.

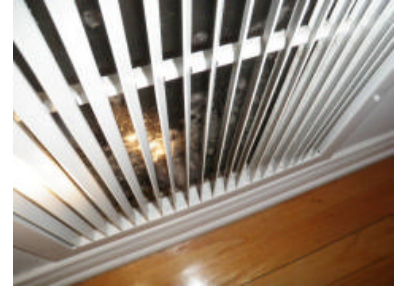
8.. AIR SUPPLY

Appears adequate / Return duct has debris present cleaning needed and consider pre-filter.

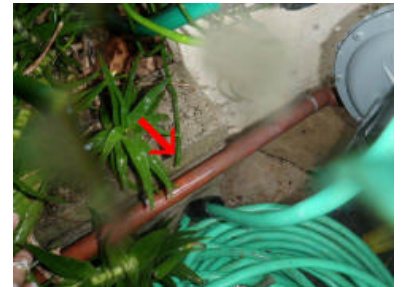
CONDITION: No active leakage is noted at this time. Monitor in the future, Appears Serviceable, Water pressure appears adequate / Most Not Accessible/Did Not Inspect / **Anchoring needed CORRECTION RECOMMENDED.**

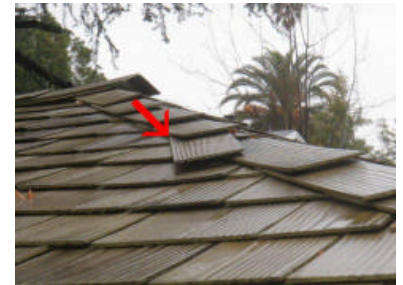
10. ROOF COMMENTS

Type/Condition: **CHECK WITH CITY BUILDING DEPARTMENT FOR PERMIT.** missing/loose shingles/tiles viewed service needed typical roof tune up condition it is recommended to have a roofing contractor familiar with this type of roofing material to make corrections needed.

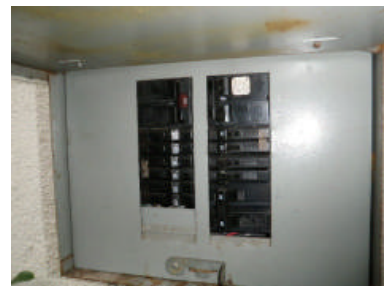
Location: main panel

Back of structure upgraded system / **CHECK WITH CITY BUILDING DEPARTMENT FOR PERMIT.**

Circuit and wire sizing correct so far as visible, Grounding system is present / Appears Serviceable / **Conditions present Panels are without the benefit of complete labeling - Access poor due to plant growth a 30"x30" access and approach is recommended / CORRECTION RECOMMENDED.**

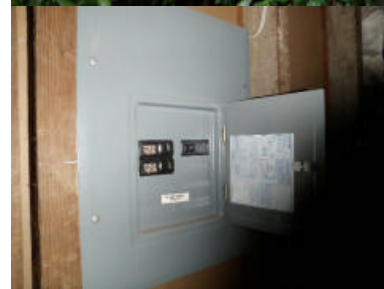
Sub panel located in basement area Appears Serviceable / **Not labeled.**

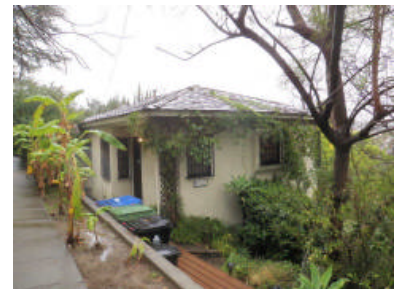
7. STUCCO

Type/Condition: Overall Appears Serviceable, Normal For Age Of Home, Normal for Age of Material / **Some areas N/A-Recommend plates/shrubs be cut away from structure. cracking present patching present consult seller on history.**

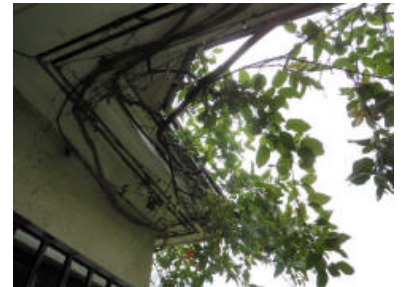
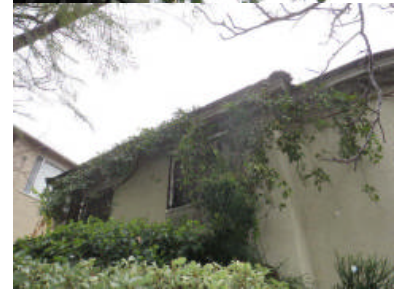
Type/Condition: N/A / **Plant growth on structure not recommended.**

For damaged wooden areas and moisture problems (mildew), consult termite report.

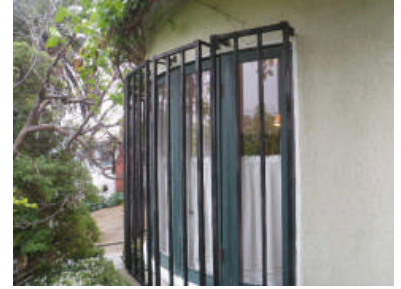
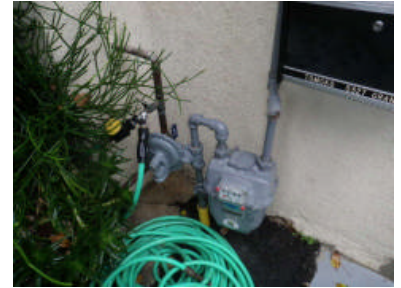
Front of home natural gas, Appears Serviceable new meter / **No seismic safety shut-off valve present consult agent.**

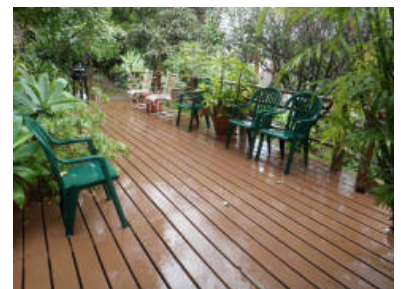
4. PATIO/PORCH/SLAB/DECK

Type/Condition: Wood Appears Serviceable, Normal for Age of Material, **CONSULT TERMITE REPORT FOR ALL WOODEN AREAS.**

Ext. Stairs/Handrails: Front entrance decorative in style non conforming to standards / Function - little loose. Leaking stair approach cracking present and multiple water intrusion areas visible, water dripping from front entrance platform ponding on wood platform- **NOT TO BUILDING STANDARDS FURTHER EVALUATION RECOMMENDED BY RESPECTIVE QUALIFIED PERTAINING CONTRACTOR WITHIN THE CONTINGENCY PERIOD.**

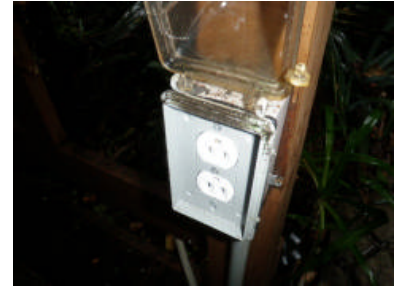
5. EXT. ELECTRICAL

Type/Condition: Appears Serviceable.
GFCI: No Units present recommend upgrading.

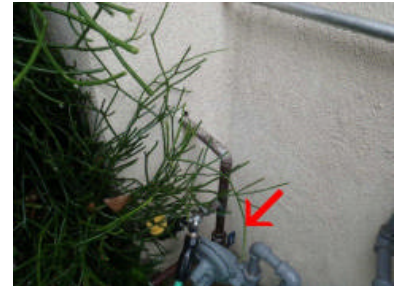
6. MAIN WATER VALVE

Location Front of home, Ball valve functional Appears Serviceable.

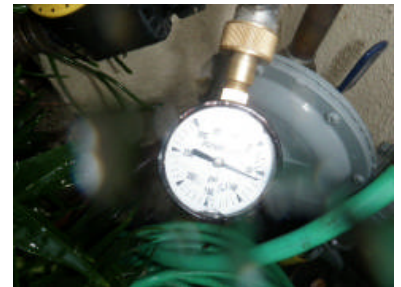
7. WATER PRESSURE

Approximate PSI 60 Serviceable.

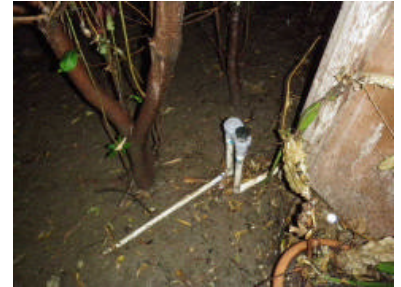
8. SPRINKLER SYST.

Type/Condition: Present not tested / Not Inspected/Excluded From Report/Consult Seller.

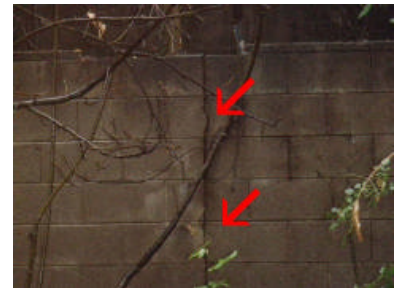
9. FENCING/WALLS

Type/Condition: Multiple materials and conditions present could not fully inspect due to shrubs and brushes / block, cracked, leaning, chain link, Normal for Age of Material could not fully inspect due to shrubs and brushes / Overall functional Normal For Age Of Home.

Gates: South leaning irregular / North covered with honeysuckle / Functional.

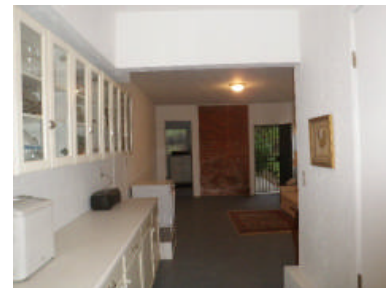
1. SLAB

Type/Condition: Basement painted concrete Appears Serviceable.

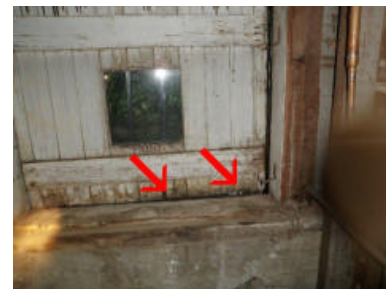
Type/Condition: Appears Serviceable, Normal For Age Of Home.

Vent Screens: torn, bent areas **CORRECTION RECOMMENDED.**

Access Cover: Door present Appears Serviceable / **Gaps present at bypassed gas meter access door recommend corrections.**

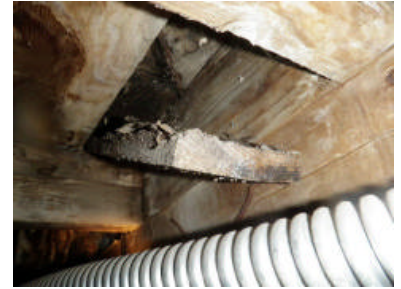
Type/Condition:

Overall Appears Serviceable / **damaged / deteriorated under shower pan CONSULT TERMITE REPORT FOR ALL WOODEN AREAS.**

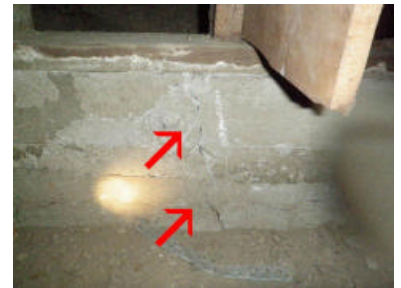
6. FOUNDATION WALLS

Poured concrete / Overall viewable areas Appears Serviceable, Normal For Age Of Home, Normal for Age of Material, **Efflorescence present / Efflorescence is the term for lime-salts leaching from concrete and crystallizing on the surface of the concrete. This can occur on floors, masonry walls, foundations and even soil. Efflorescence is not the problem. The root cause is moisture, and this will continue to be a problem until you address the source of that moisture. Most likely, in your case, the source is irrigation in summer and poor drainage in winter. Cracks present South Further Evaluation Recommended By Related Qualified Licensed Foundation Contractor Within Contingency Period / rain water against structure leaching into structure foundation - lifting, trip hazard present preventing proper water egress- Roof gutters recommended / Further Evaluation Recommended By Related Qualified Licensed drainage Contractor Within Contingency Period.**

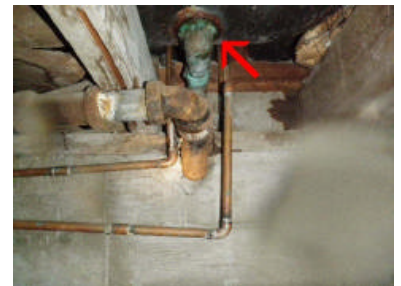
8. PLUMBING

Type/Condition: Supply / No leakage is noted, but monitor in the future / Minor corrosion is noted / Normal for Age of Material Appears Serviceable / **Major corrosion is noted at bathroom Galvanized vertical feeds original plumbing recommend completing upgrading System appears to be nearing/at end of its useful life.** Waste / Leaks noted at tub drainage system heavy corrosion present Further Evaluation Recommended By Related Qualified Licensed Contractor Within Contingency Period / DRAINAGE TESTING Note that water is ran continuously in Kitchen and bathroom's during inspection of that area slow drainage is noted if occurring however it is beyond the scope of this inspection to report or have access to main drain condition. It is recommended for properties 1950 and older to do a video line interior inspection to determine condition of main drain line / **Sewer line video conducted consult contractor on findings.**

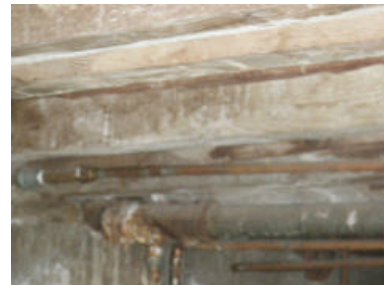
10. BASEMENT/CRAWL SPACE:

ACCESSIBILITY: Basement is fully accessible, Crawl space is fully accessible / Small access and staggered concrete present some area South appears to be possible past steps - See foundation report conducted.

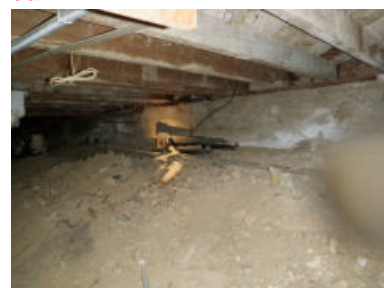
CRAWL SPACE: Remove wood debris and trash from the crawl space area.
BASEMENT WALLS - TYPE: Poured concrete. See foundation report conducted.
