Report Index

INSPECTION CONDITIONS

FILE #: 598 - 032217JS Inspection Order Number (OID): 598.
DATE OF INSPECTION: 3/22/2017.
TIME OF INSPECTION: Start time 8:30 Am.
CLIENT NAME: SAMPLE REPORT.
INSPECTION SITE: 1820 Fairmount Ave.
INSPECTION SITE La Canada Flintridge, CA 91011.
CITY/STATE/ZIP:

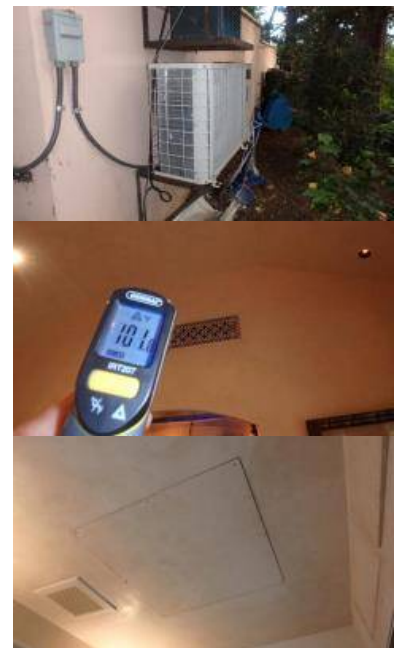
Blower not accessed - cannot determine return air -
Access in pool house bathroom ceiling.

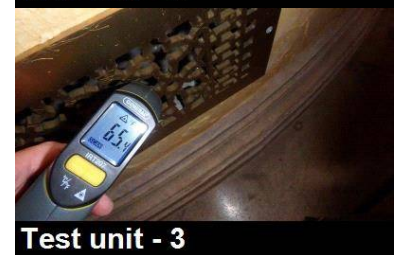
Test unit - 3

Unit - 1 Appears Serviceable - **damaged insulation noted at roof correction required** / Unit - 2 Not Accessible/Did Not Inspect / Units 3 & 4 underground Freon lines most Not Accessible/Did Not Inspect **visible damaged insulation noted exposed copper corrections required** / Unit - 5 underground Freon lines most Not Accessible/Did Not Inspect, **visible damaged insulation noted exposed copper corrections required, missing insulation into structure Recommend sealing flashing access with Steel Wool and or Spray Foam to prevent Rodent access** / Unit - 6 N/A. **Recommend service by a licensed heating/air conditioning contractor.**

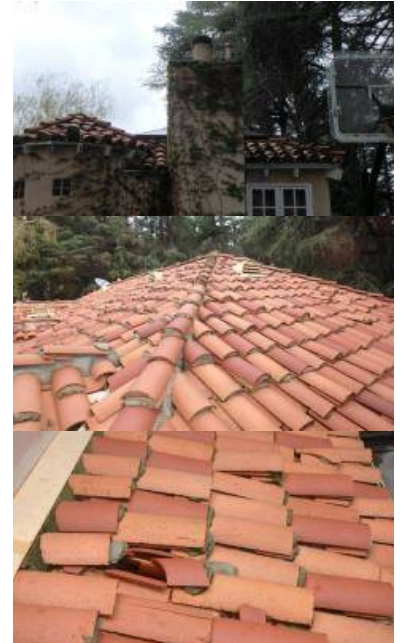
Spanish clay double/triple system present appears serviceable, **Conditions present, excessive tree debris present, multiple cracked, slipped tiles present, exposed underlayment A professional roof tune up is required at this time. Recommend licensed roofing contractor for further evaluation Further Evaluation Recommended By Related Qualified Licensed Contractor Within Contingency Period.** Rolled asphalt Serviceable life in material at this time. Monitor wear in future.

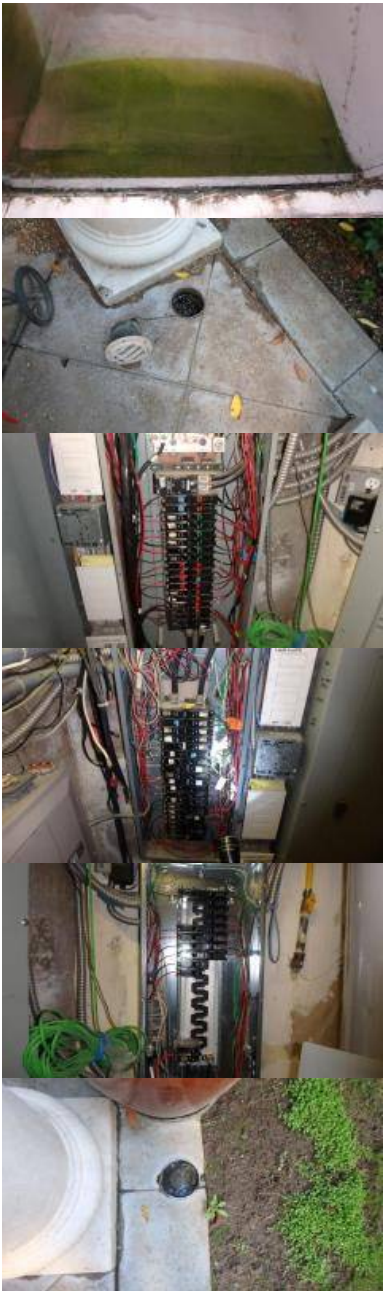
All panels inspected.

Complete low voltage inspection recommended.
